BOROSCOPIC INSPECTION REPORT

PHASE 3

25 SIGOURNEY STREET HARTFORD, CT

OCTOBER 22, 2002

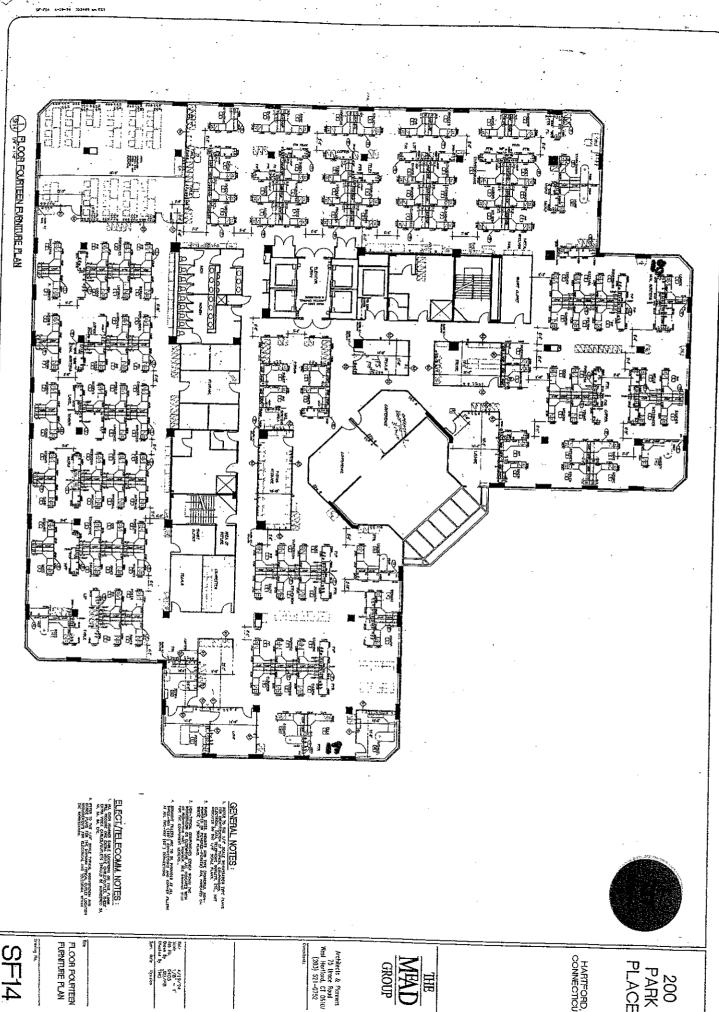
FLOOR FOURTEEN

LOCATION #17C: This is in 2nd office facing East. Area was clean, but heavy debris found.

LOCATION #18C: This is in corner office facing Northwest. Area was clean, but heavy debris found.

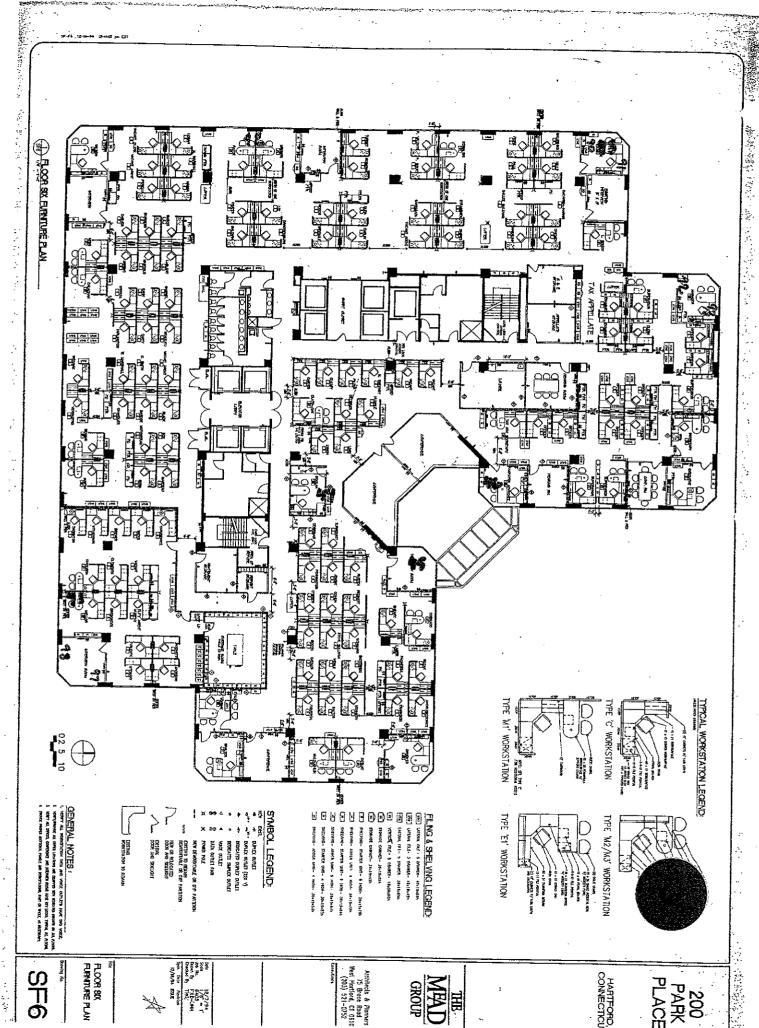
SF6

LOCATION #42C: This is in a column wall near Platte's work station. Water stains on gypsum board and rust on studs found.

LOCATION #45C: This is in a window wall in the interview room facing West over the atrium roof. Rust on studs found but no water stains on gypsum board found.

LOCATION 9C, LOCATION 19C, LOCATION 39C, LOCATION 42C, and LOCATION 50C.
